<b>GROUP</b> <b>Engine</b>	<b>MODEL</b> <b>All Models w/3.3L GDI Engine</b>
	<b>NUMBER</b> <b>PS417</b>	<b>DATE</b> <b>July 2015</b>

**SUBJECT: DTC P0315 - CRANKSHAFT POSITION (CKP) SENSOR VARIATION NOT LEARNED**

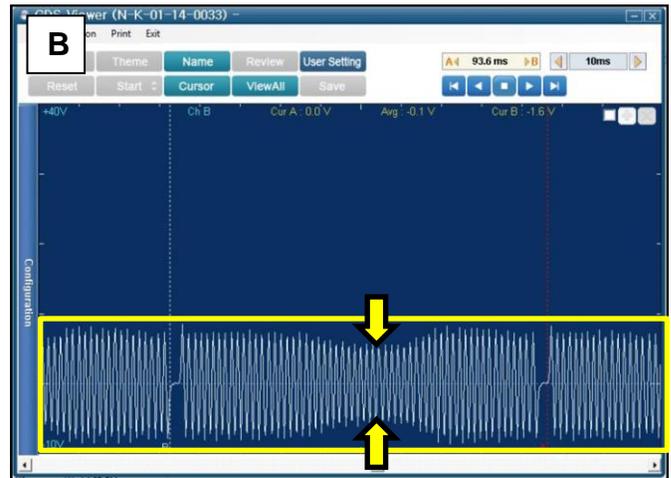
Crankshaft Sensor deviation

When encountering a customer complaint of engine misfire with a Malfunction Indicator Light (MIL) on in the dash, check for the presence of DTC P0315 – Crankshaft Position Sensor (CKP) Variation Not Learned. Use the VMI to view the scope pattern of the crankshaft position sensor signal. Verify a good equal crankshaft sensor pattern is present with no dips or variation, as shown in Figure A, in the sign wave pattern. If the pattern is identical to Figure A, Use GDS/KDS to perform a crank sensor relearn procedure. If the pattern shows a dip or variation, as shown in Figure B, replace the flex plate to resolve the concern.
